Achieving airtightness in new dwellings: case studies

Case study 1: Osborne Demonstration House, Watford

Case study 2: Dartmouth Avenue, Woking and Glaziers Lane, Normandy, Guildford

Case study 3: Stamford Brook, Cheshire

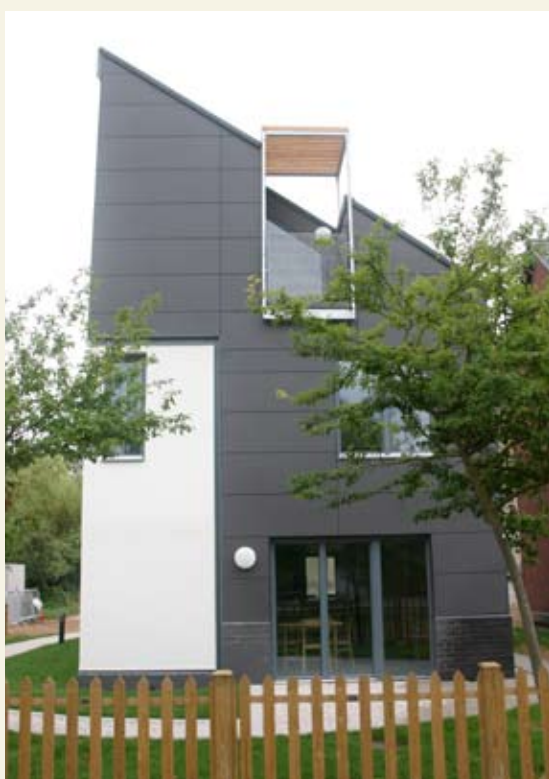
The demonstration house was constructed on the Building Research Establishment's Innovation Park.

The Osborne house uses Structural Insulated panels (SIPs), which are typically two sheets of lining material fixed to either side of a pre-formed timber frame. The lining material is usually oriented strand board (OSB), as used in this development, or cement-based boards. The benefits of using SIPs in construction are the relatively few studs/thermal bridges present and ease of use – the external wall shell system was erected in just two days.

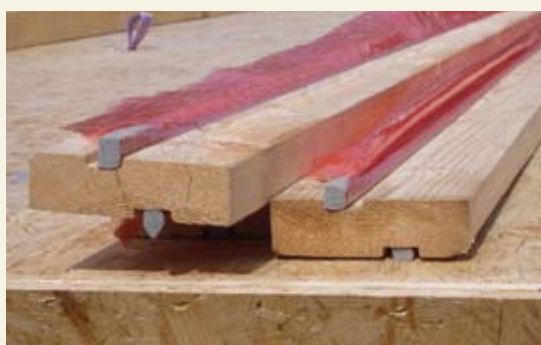
Figure 1 Foam tape is applied to sole plates which expands in place to seal between joints

The airtightness strategy was based upon using the OSB casing of the SIPs as the air barrier and creating a seal at the panel junctions using resin impregnated foam tape (see Figure 1).

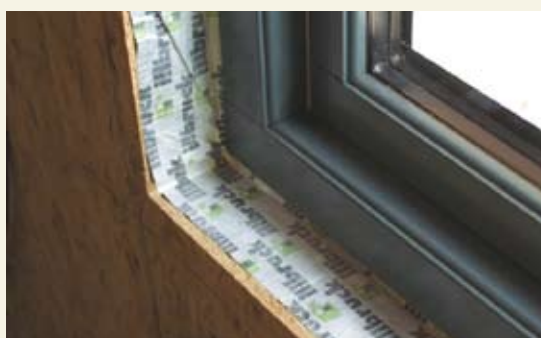
Figure 2 Sealing tape applied to window frame and wall junction

Windows and doors were sealed using fabric-reinforced, tear-resistant aluminium foil, and service entries were sealed using gaskets and polyurethane foam (see Figure 2).

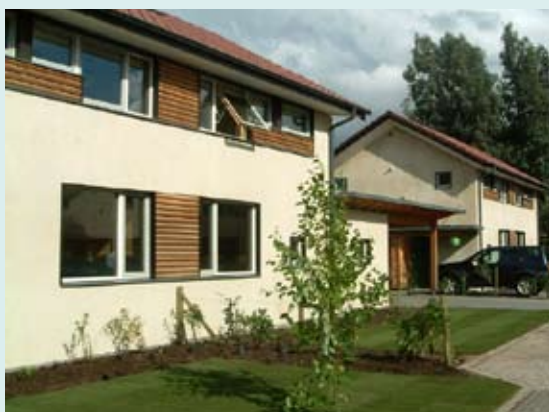
These two developments build on the experience Jon Broome architects have in 'green' building. The design and specification was based on the Energy Saving Trust's best practice standard incorporating low energy sustainable construction by using the lowest carbon performance and build methods available within a mainstream housing budget.

The Dartmouth Avenue and Glaziers Lane developments used a prefabricated timber frame panel construction with roof, ground and intermediate floor cassettes. An airtight vapour control layer (VCL) with taped joints was used for the interior, whilst a breather membrane was used externally.

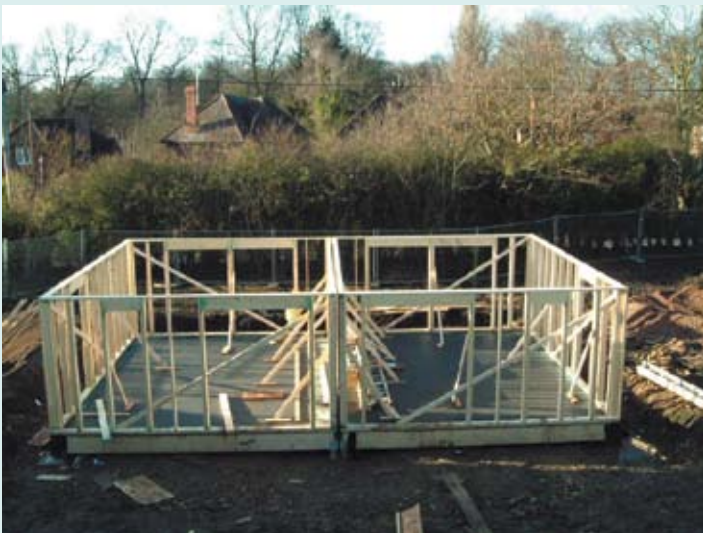
Figure 3 Timber frame construction on site, Glaziers Lane

The membrane was replaced in parts and the tape was reapplied generally to rectify the situation. Also the quality of fabrication and erection of the prefabricated timber frame, which included the air barrier, was below standard. The prefabricated timber frame was omitted on the Glaziers Lane development and instead built on site (see Figure 3).

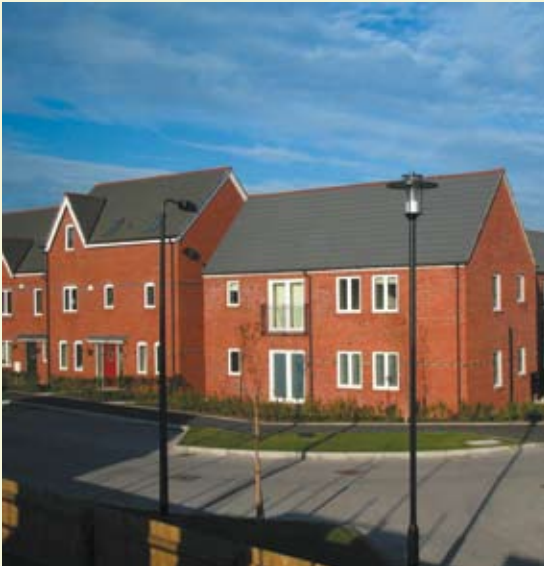
The Stamford Brook development of over seven hundred dwellings exemplifies energy efficiency in modern domestic masonry construction. To achieve this, Redrow and Bryant homes have worked in partnership with both Leeds Metropolitan University and the National Trust.

The Stamford Brook development demonstrates a best practice airtight standard using modern masonry cavity construction as part of a larger research project⁶. This was achieved by using the appropriate materials and due diligence on-site.
